Local Government Engineering Department (LGED)
Government of the People's Republic of Bangladesh

Draft Final Report on
MONITORING THE PERFORMANCE OF
VILLAGE PROTECTION, MODEL VILLAGE, UPAZILA/UNION
ROAD, SLOPE PROTECTION

Haor Infrastructure and Livelihood Improvement Project (HILIP)

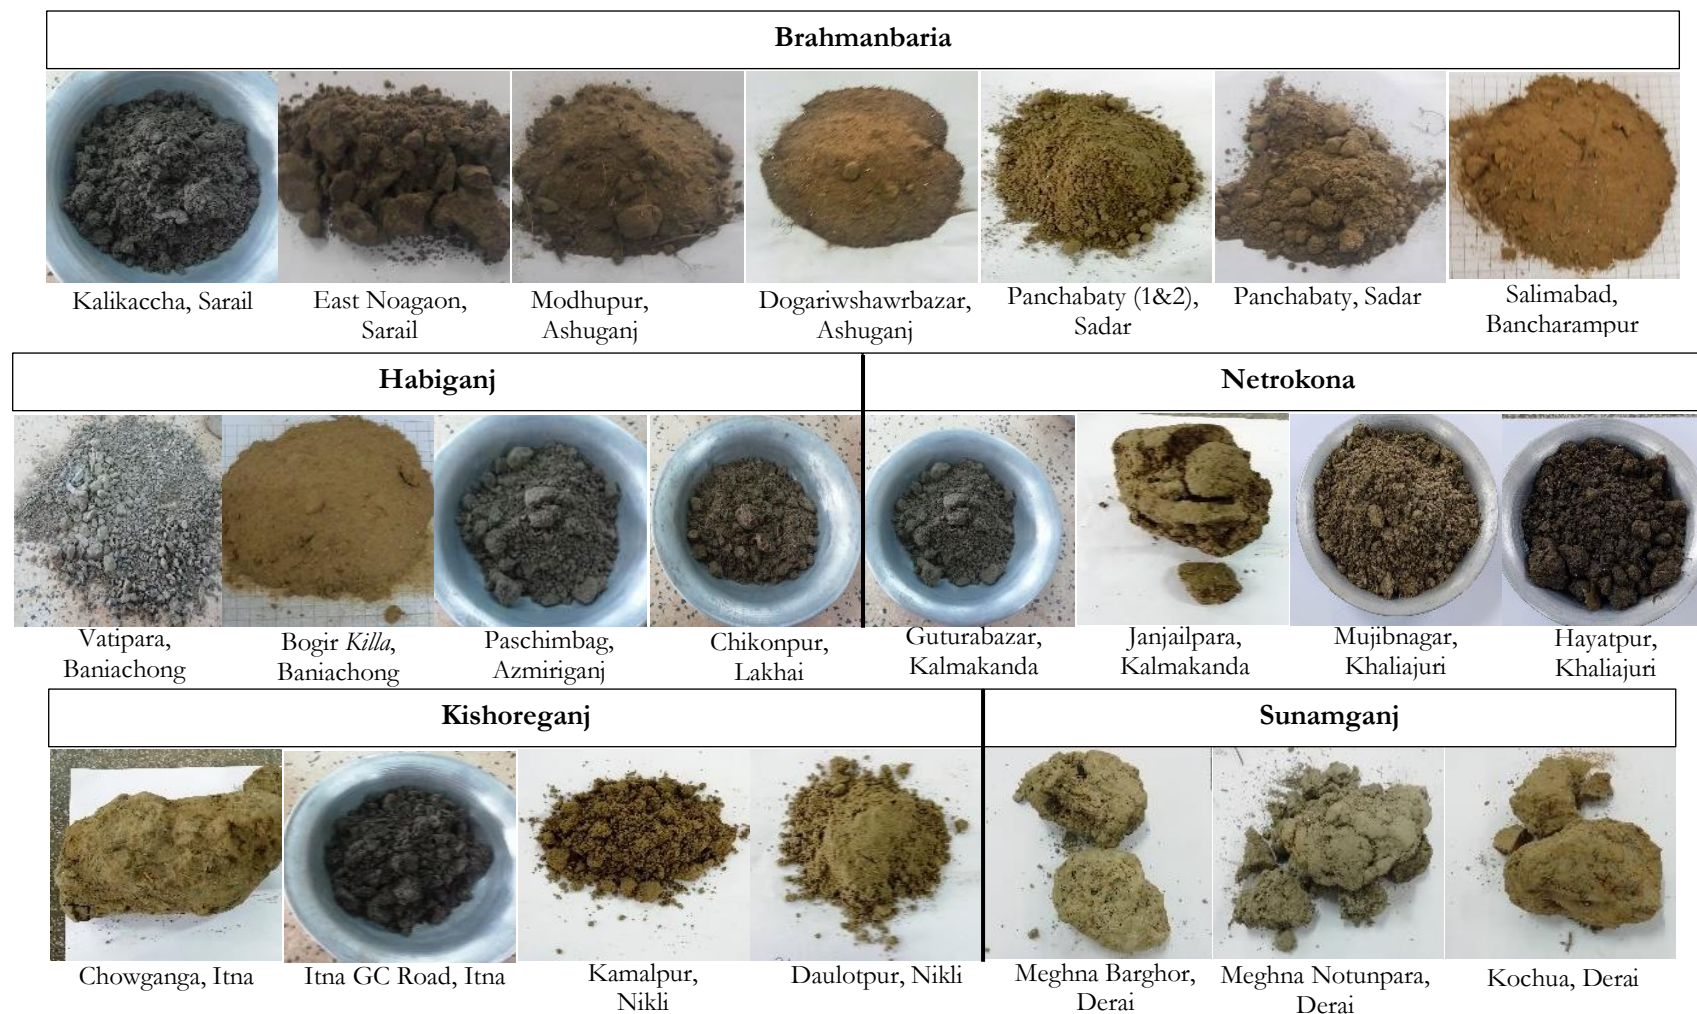
Figure 3.1: Visual Photographs of *Haor* Soils

Table 3.1 summarizes the soil type, Fineness Modulus (FM) and specific gravity (G_s) of the soils collected from field study areas. Figure 3.1 shows the photographs of all collected soils from five *haor* districts.

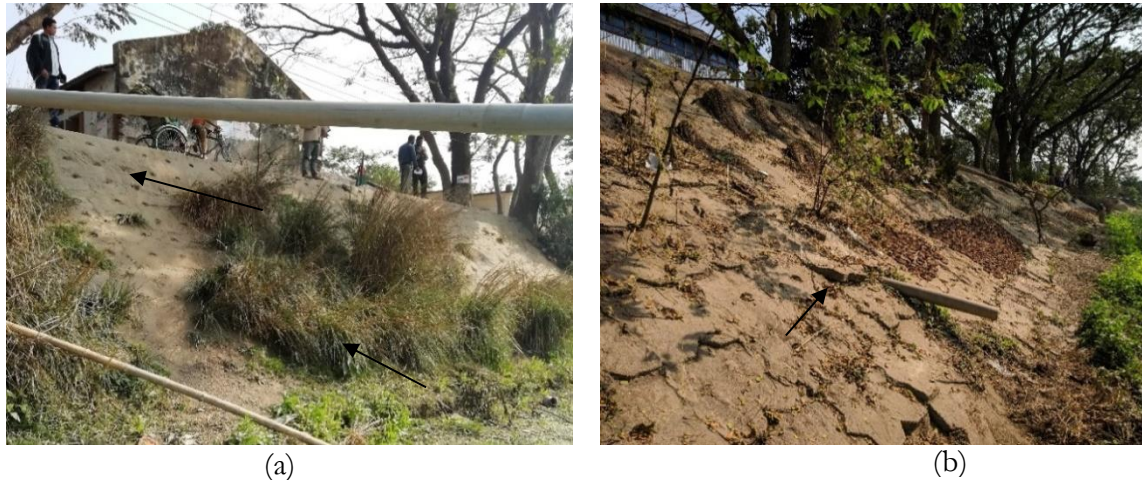
Figure 3.7 shows the condition of slope protection works in Kalikaccha UP- Bariura Bazar Road in Sarail Upazila of Brahmanbaria district. This site faced submergence by four monsoon periods. The slope seemed to be steep (1:1, V:H), and design type III as implemented. After about two years, it is seen that around 200 vetiver tillers have been grown from two planted tillers. Figure 3.7 (b) shows the broken CC blocks along with the

slopes where no vetiver tillers were found, which occurred due to lack of bondage with soil. It indicates that the growth of vetiver is very good, but as maximum tillers were uprooted by local people, and for poor maintenance of the site, garbage disposal the overall performance of slope protection was not satisfactory enough.

Figure 3.7: Photographs of (a) Slope Condition at 14th January 2019; and (b) Loosened CC Blocks along Slope

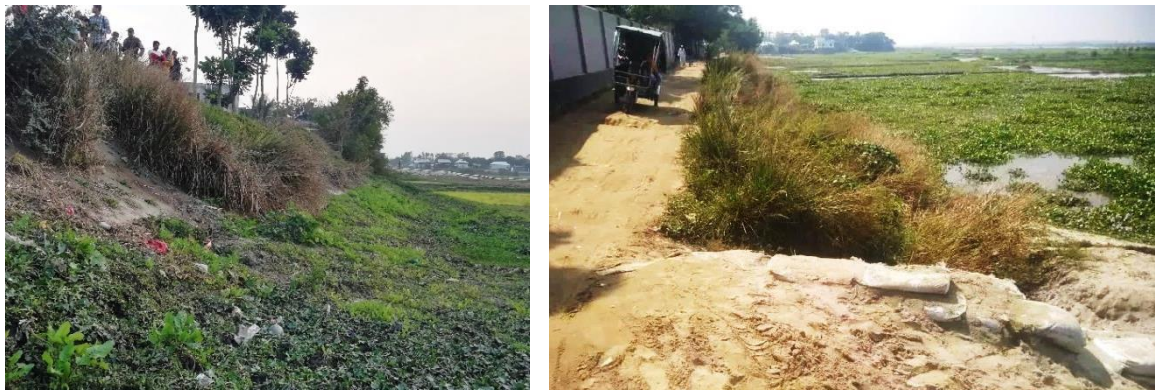
Slope protection work at Modhupur Temohoni to Lalpur R&H via Lalpur UP & GC Road, Ashuganj, Brahmanbaria is situated beside a branch of the river *Meghna*. The applied design scheme was Type III (CC block with hole) with earthen pavement here. Figure 3.8 (a) shows the photographs of slope condition and vetiver growth at 14th January 2019, where Figure 3.8 (b) is stating the slope condition at 16th November 2019. The performance of vetiver growth was quite well along 100 m strip in this site, so the road slope is well protected against rainfall, submergence and wave action for three monsoon periods.

Figure 3.8: (a) Slope Condition after Facing Two Monsoons; and (b) Slope Condition after Facing Three Monsoons

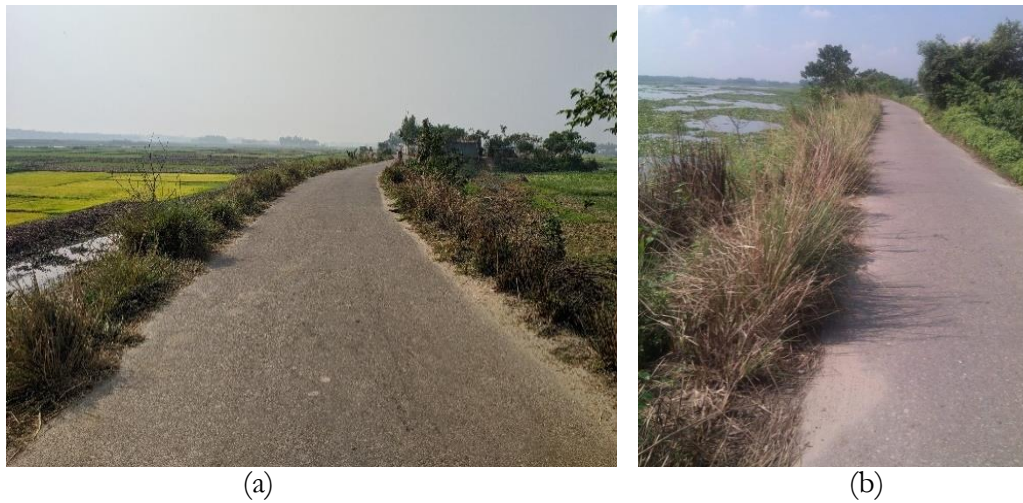
Improvement of slope protection work at North West Side Bridge Approach R&H Road under Salimabad UP to Faridabad union, Bancharampur, Brahmanbaria is situated alongside a river named '*Titas*' and a swamp named '*Kaizkor beel*'. The slope improvement of the approach road in south side is conducted by LGED, where the design scheme was Type II, vetiver tillers were planted on both slope and shoulder of the road. Figure 3.9 (a) shows the road geometry after facing three monsoon periods with rainfall, submergence and wave action, where vetiver tillers were burnt down and new tillers were not grown yet. Vetiver

tillers were burnt by local people for abundance of rodent residents and robbery nuisances. Figure 3.9 (b) shows the road condition after facing four monsoon periods. New vetiver tillers were grown within this interval from burnt shoots.

Figure 3.9: Site Condition of Salimabad, Bancharampur, Brahmanbaria at (a) 15th January 2019; and (b) 16th November 2019

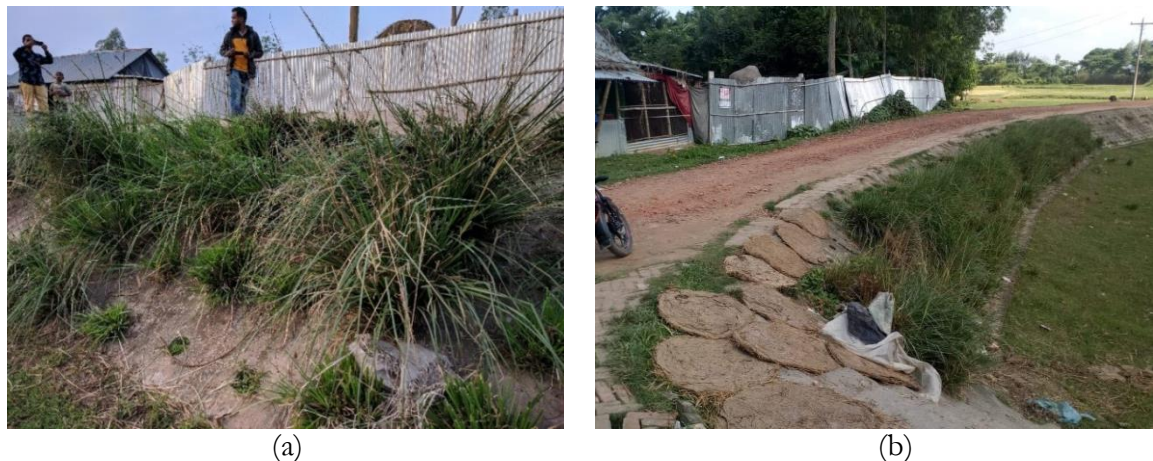
Habiganj is mid-depth *haor* according to depth among all *haor* districts. The slope ratio of road slope protection on Pashchimbag-Azmiriganj Road, Azmiriganj, Habiganj was found as 1:1 (V:H). In this site, design Type III was applied. The plantation area of this site is rural populated area, so numerous disturbances were observed. Figure 3.10 (a) shows state of the slope at 26th January 2019, whereas Figure 3.10 (b) is the slope condition at 18th November 2019, after facing rainfall and submergence. The growth of vetiver was good, but due to poor maintenance, maximum hole of CC blocks became blank which expedited slope failure during monsoon.

Figure 3.10: (a) Slope Condition of the Paschimbag, Azmiriganj, Habiganj after Facing Two Monsoons; and (b) Slope Condition of the Site after Facing Three Monsoons

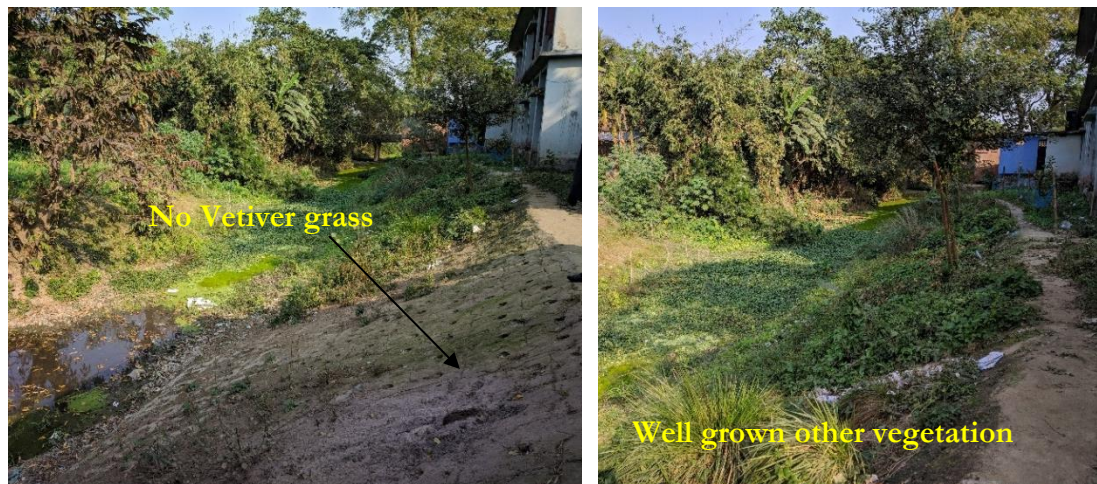
In Brahmanbaria, a village protection work at East Noagaon Village near Noagaon GPS, Sarail was conducted, where the slope ratio was found as 1:2.4 (V:H).

Figure 3.13: Village Protection work at East Noagaon, Sarail at 14th January 2019

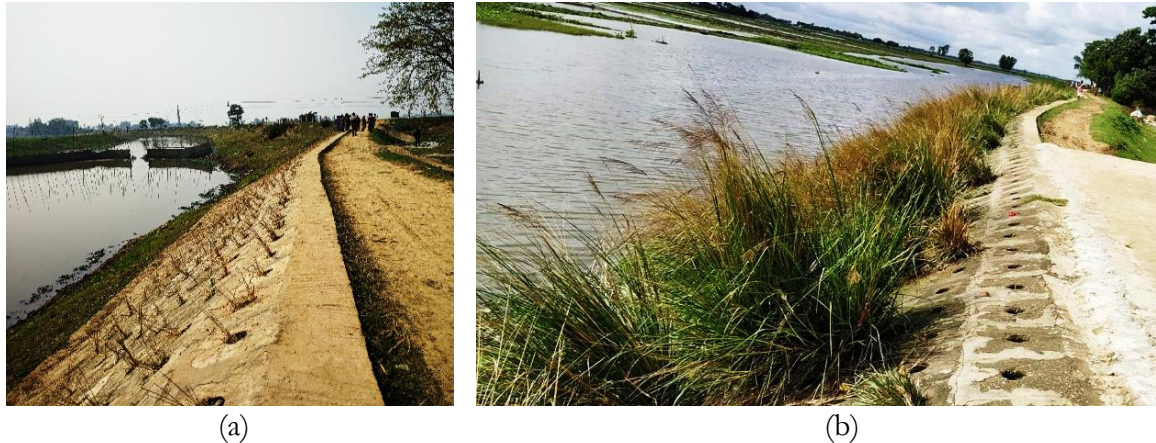
inundated at monsoon. So replantation was done on 2nd January 2019. Figure 3.14 (a) shows the slope condition on 26th January 2019, after 24 days of the plantation. Figure 3.14 (b) shows the condition on 18th November 2019, after facing a flood. As the plantation was done in dry season, the tillers grew properly and when rainfall and flood occurred, the tillers protected the overall slope by preventing washing away the CC blocks and soils. At this location, swamp trees named “Koroch” are found, which are highly water resistant that can survive long duration of inundation during the rainy season.

Figure 3.14: Photographs of Slope Condition at Vatipara, Baniachong, Habiganj: (a) 24 Days after Plantation; and (b) After Facing One Flood

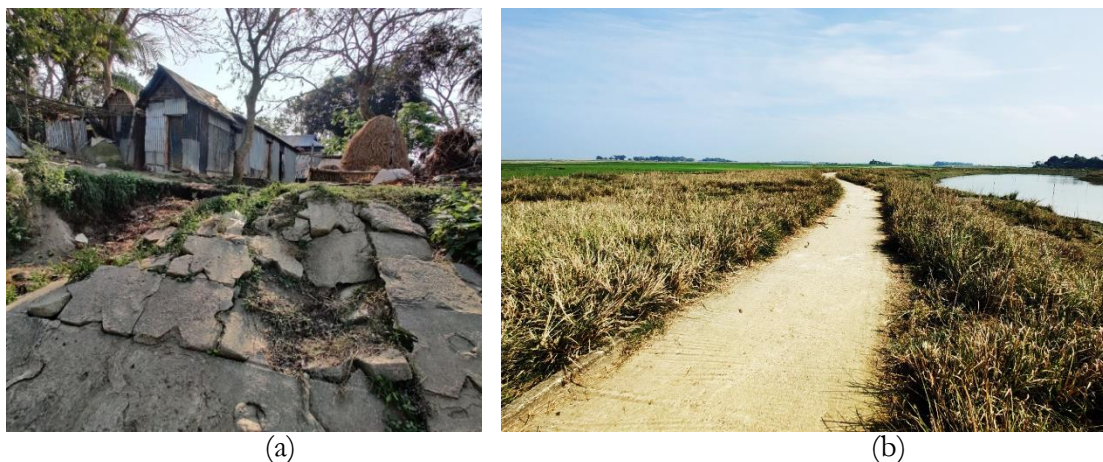
In Netrokona, village protection work in Hayatpur was conducted in Khaliajuri Upazila at 9th February 2020, which faced three monsoon periods with full submergence and wave action. The slope ratio was found as 1:1.5 (V:H) as per design schedule, and design type III was applied on this site. Block holes were found as sealed off by mortar and the slope surface was filled by sandy soil at this site. So the slope failed by loosening the blocks as shown as Figure 3.15 (a), since there was no interaction within the protection system and the soil. Some vetiver tillers were found at the toe of the slopes at the site. A vetiver source was found at the same village and the growth of the tillers was found excellent after facing three monsoons, as shown as Figure 3.15 (b). Although this site was also surrounded by deep *haor*, the condition of the road of vetiver source was found good due to proper protection, which indicates the submergence tolerance of vetiver tillers.

Figure 3.15: (a) Broken Slope by Sealed Block; and (b) Vetiver Source at Hayatpur, Khaliajuri, Netrkona

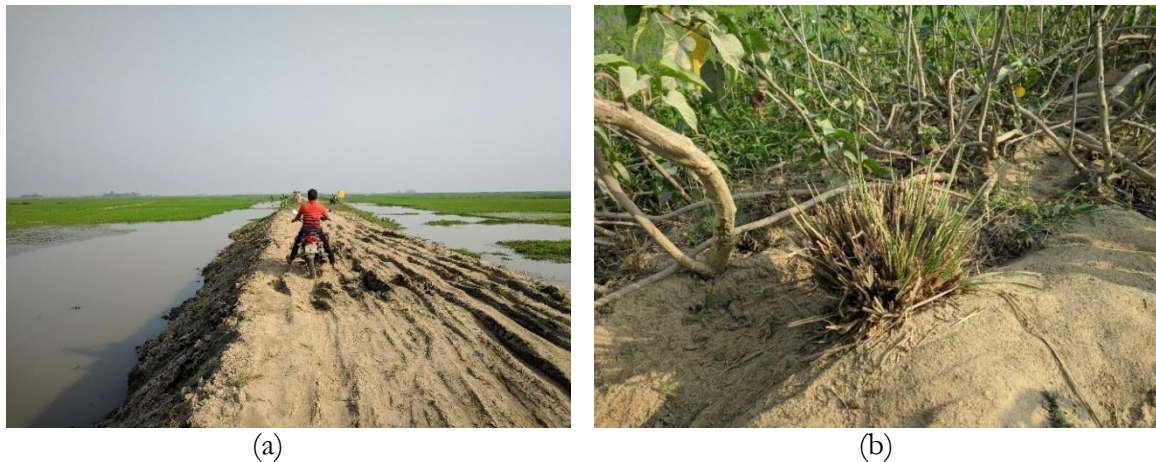
Only three vetiver samples were found in this site shown in Figure 3.17 (b). In place of vetiver tillers, a species of shrub named “Dholkolmi” was planted after the flood in this area.

But the overall condition of the site seemed worn-out due to poor maintenance.

Figure 3.17: Photographs of Bogir *Killa*, Habiganj: (a) Submergible Road Condition; and (b) Very Few Vetiver Tillers Found at the Site

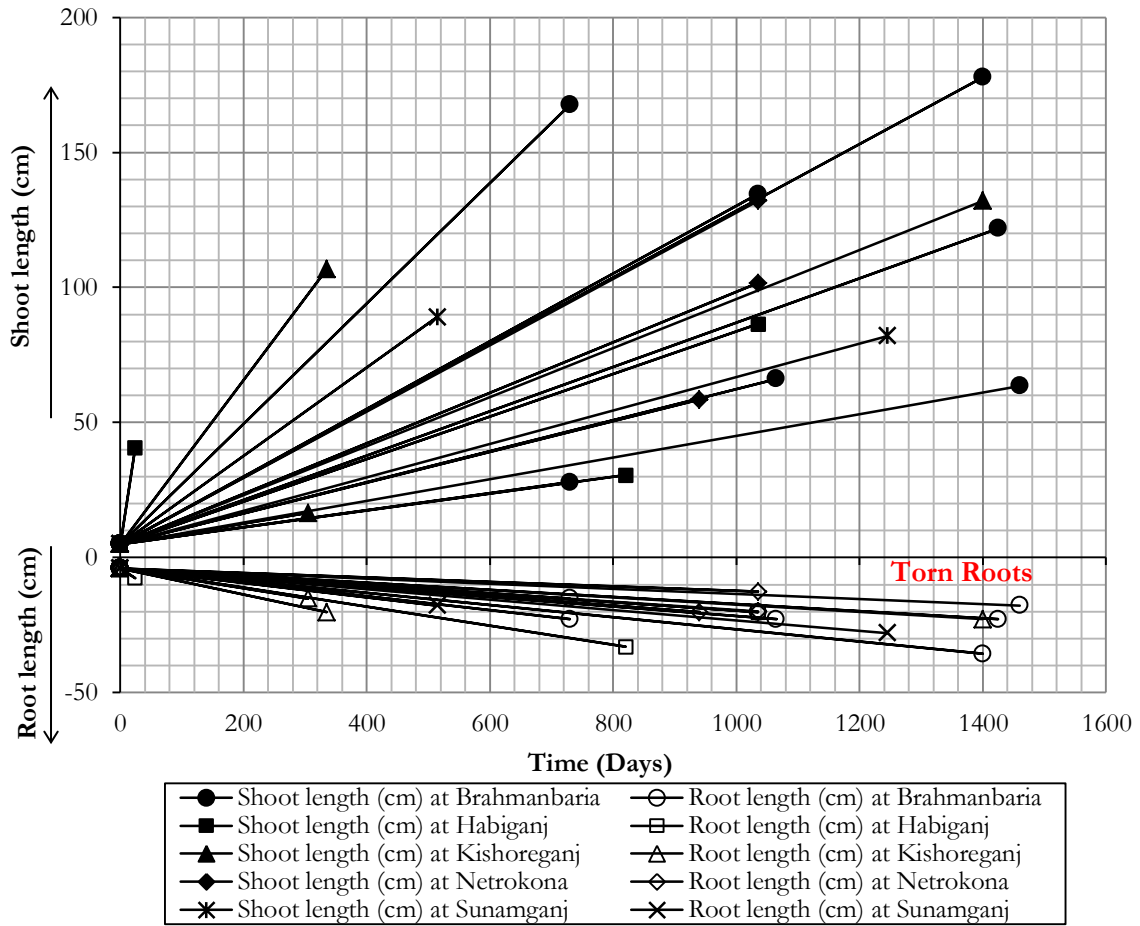
In Netrokona, the range of maximum of shoot and root length of vetiver were found as 58.4-132.1 cm and 12.7-20.3 cm. In Sunamganj, the range of maximum of shoot and root length of vetiver were found as 82.0-89.0 cm and 17.8-27.9 cm. The age of the tillers was 737-1035 days for Netrokona and 515-1245 days for Sunamganj.

Figure 3.18: Growth of Vetiver in Haor Region

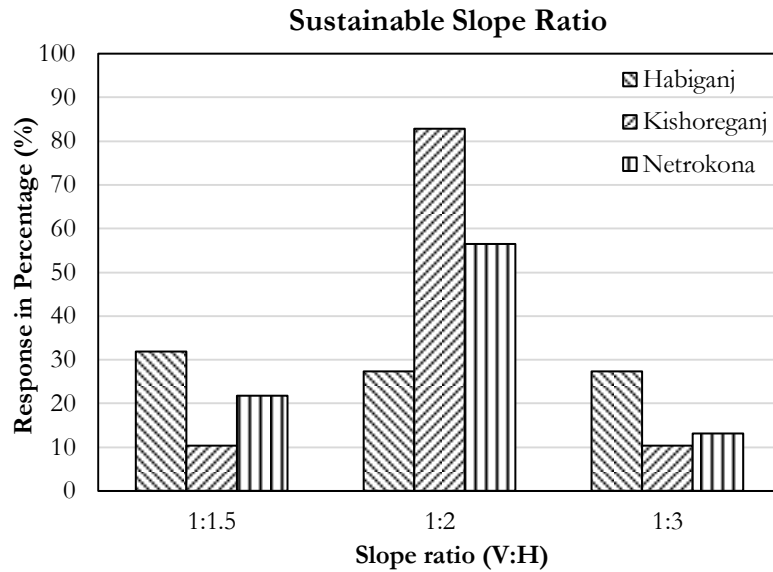
sandy soil, the slope ratio should be 1:2 and 1:3, respectively. From Figure 3.23, it can be observed that *haor* people think that 1:2 is the proper sustainable slope ratio.

Figure 3.23: Proper Slope Ratio to be maintained for *Haor* Infrastructures

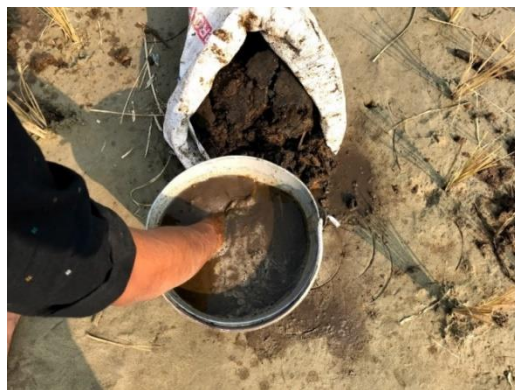
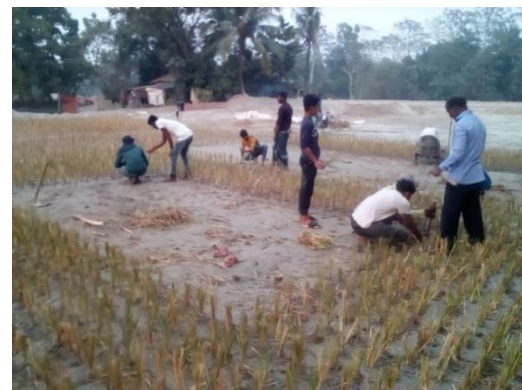
Figure 4.3: Photographs of (a) Application of Cow Dung Manure; and (b) Planation of Tillers at Nursery

Index and chemical properties of nursery soils should be determined before planation if possible for evaluating the necessity of fertilizers or additives. Mostly, ground plantation requires application of fertilizer to an extent (e.g. Di Ammonium Phosphate, cow dung shown in Figure 4.3a).

Plantation can be done on ground in grid pattern with 23-30 cm c/c distance and 3 tillers per point, depending on the available space in the nursery plot as shown in Figure 4.3 (b). Watering is required twice in a day in case of lower water level or insufficient amount of rainfall, (Figure 4.4a). Otherwise, watering once in a day is adequate. Rain cover is required if nursery is constructed in the monsoon period (April to October) as presented in Figure 4.4 (b).

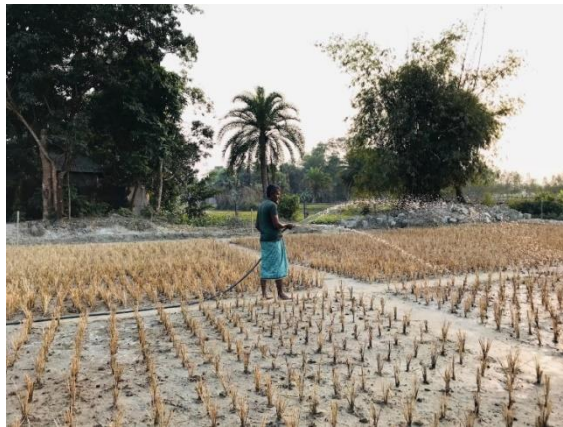
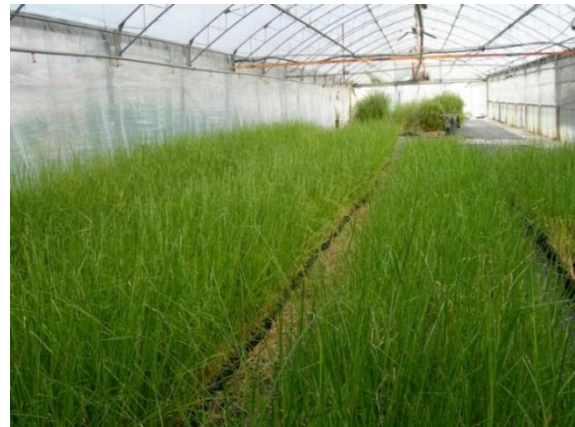
Figure 4.4: Photographs of Nursery of (a) Watering for Pre Monsoon Plantation; and (b) Rain Cover Protection for Post Monsoon Plantation

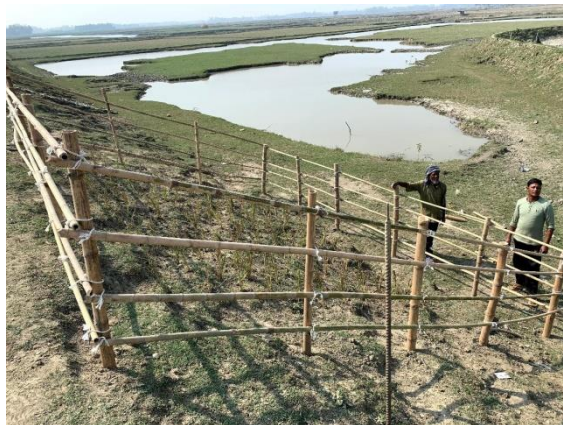
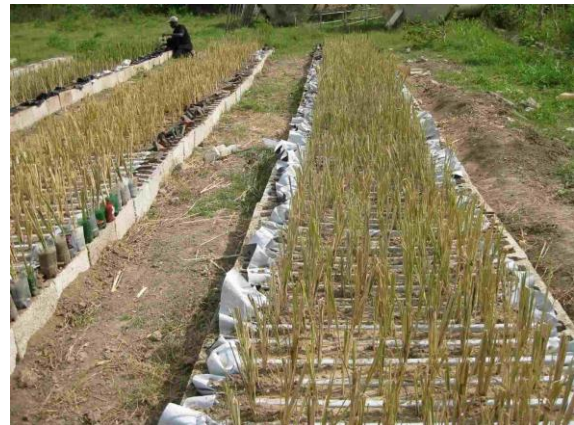
Figure 4.5: Photographs of (a) Site Protection by Bamboo Fencing; and (b) Vetiver Tillers Planted in Polybag at Nursery

Vetiver planted in nursery requires at least 120 days for growing fully. Regular care and observation (e.g. trimming, weed separation etc.) have to be ensured within this duration. Construction of bamboo fence is required to prevent human and livestock disturbances as shown in Figure 4.5 (a). A strap of polymer nets can be provided around the fence for better

If nursery bed soil is unsuitable for plantation and if the water table position is found as very low, plantation can be done in polybags (Figure 4.5b) with better-quality nursery soil (sandy soil/clayey soil mixed with cow dung, fly ash and peat moss). As *haor* region remain submerged for most of the time of the year, proper growth of vetiver becomes difficult. For these areas, vetiver cultivation by hydroponics can be an efficacious system. Hydroponics is a subset of hydroculture, which is a method of growing plants without soil, by instead of using mineral nutrient solutions in a water solvent, shown in Figure 4.6.

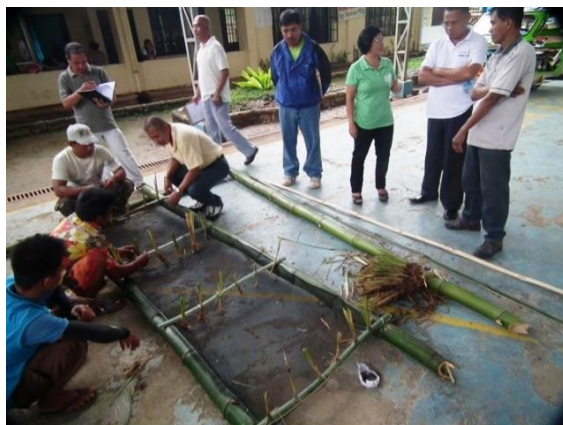
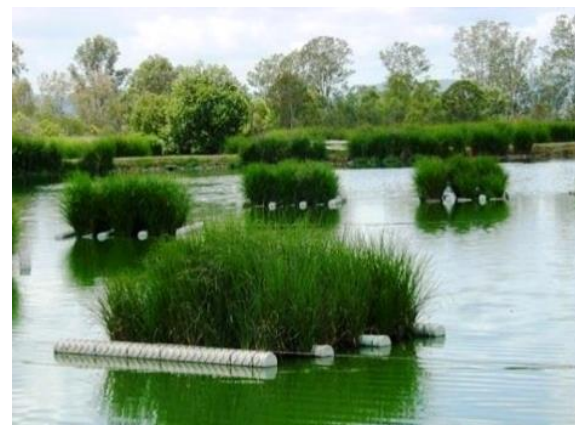
Figure 4.6: Photographs of (a) Vetiver Tillers Planting on Rafts; and (b) Hydroponics by Vetiver (www.slideshare.net/mik1999/vetiver-for-terracing-and-stabilizing-soil)

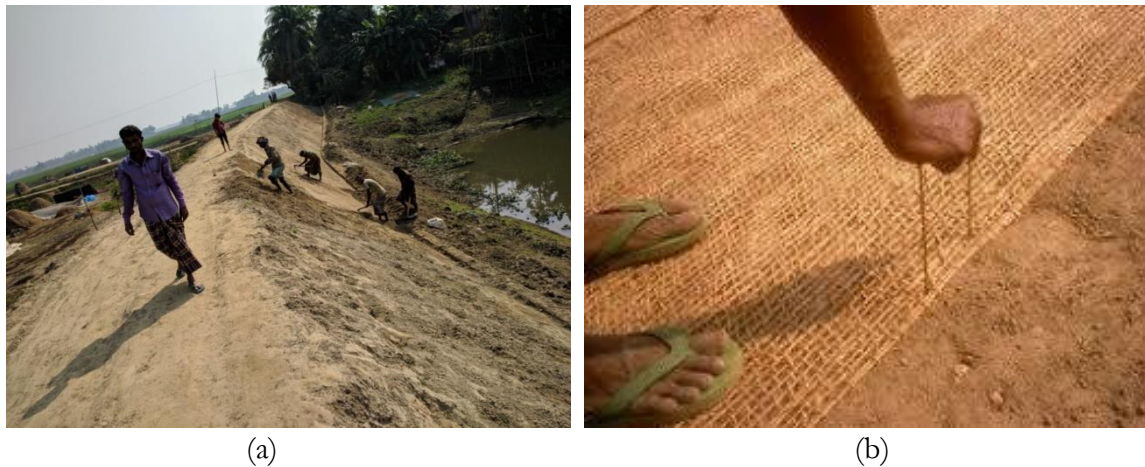
Figure 4.10: Photographs of (a) Slope Preparation by LCS; and (b) JGT Placement on Prepared Slope

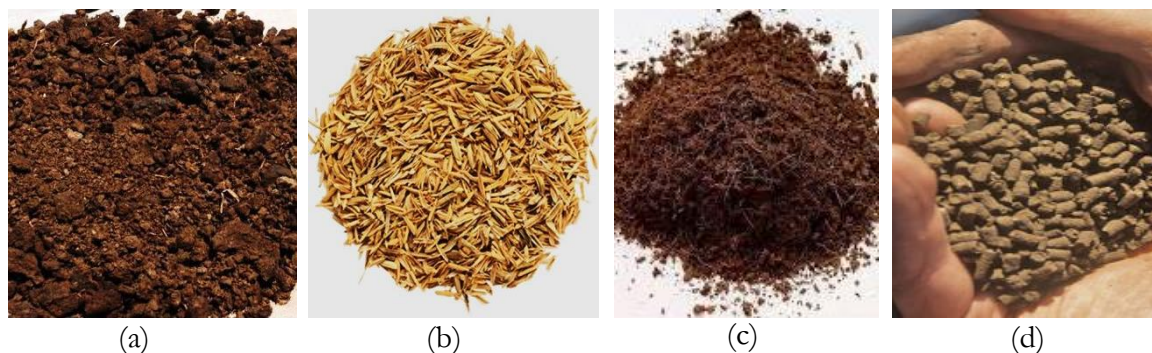
Figure 4.11: Photographs of Organic Fertilizers; (a) Cow Dung, (b) Rice Husk, (c) Coconut Dust and (d) Poultry Droppings

Application of organic manure is necessary in some cases, i.e. nursery preparation, plantation of vetiver in dry season and in unfertile soil. In order to use fertilizer for vetiver, location specific soil analysis has to be done properly. Some examples of organic fertilizers for vetiver plantation (Figure 4.11) are: (1) Cow dung; (2) Rice husk; (3) Coconut dust; (4) Poultry droppings.

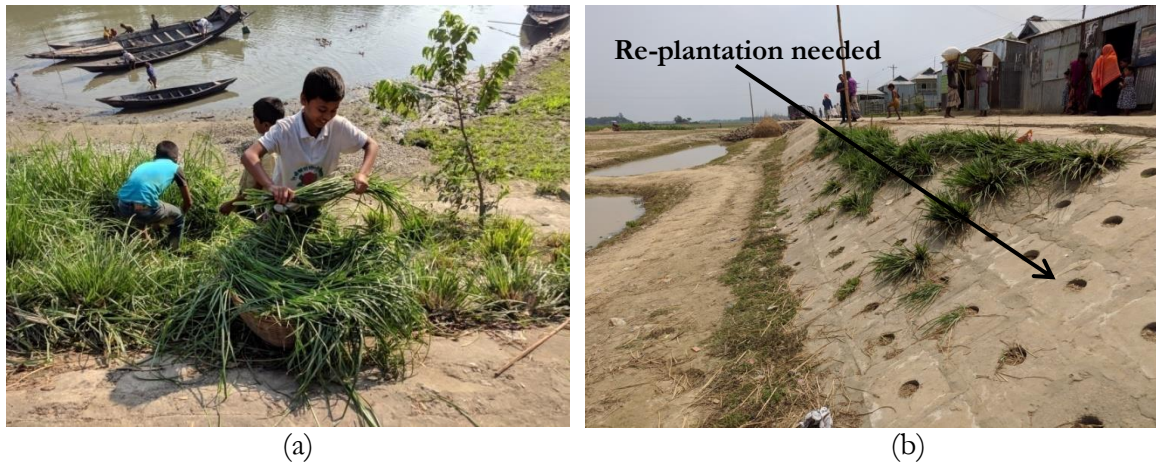
Figure 4.12: Photographs of (a) Trimmed Vetiver for Multi-purpose Uses; and (b) Replantation Requirement Scenario
