## **ENVIRONMENTAL AND SOCIAL ASSESSMENT (ESA) REPORT FOR**

**Package No: RUTDP/KUS/2024-25/W-01**

**Kushtia Pourashava, Kushtia**

**Resilient Urban and Territorial Development Project (RUTDP)**

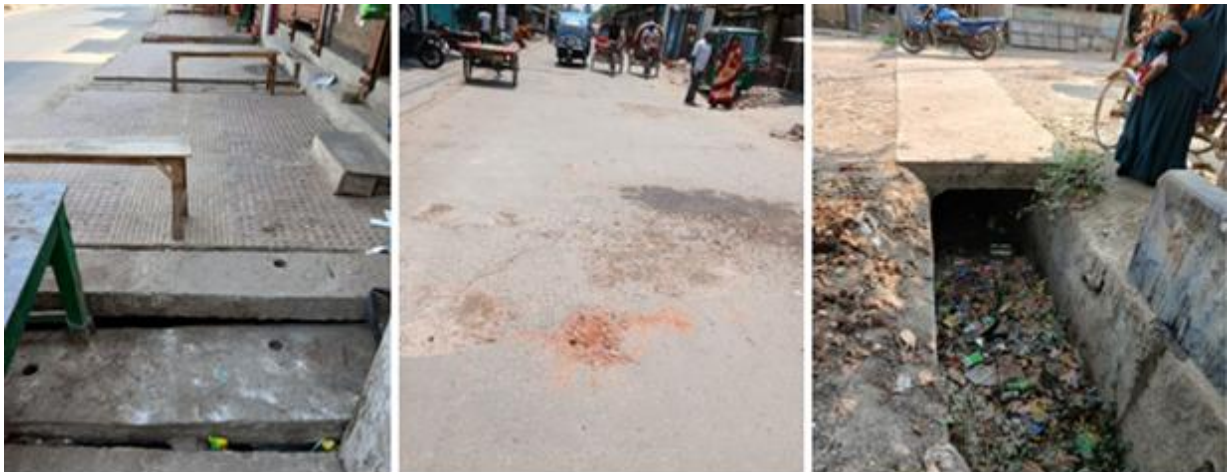
#### Current Situation of the Subproject:

- Roads are **damaged, potholed, and narrow**, disrupting traffic and livelihoods.
- Existing **drains are inadequate** and cause waterlogging during monsoon.
- **Old and insufficient streetlights** compromise night-time safety.
