**ENVIRONMENTAL AND SOCIAL ASSESSMENT (ESA) REPORT  
FOR**

**Package No: RUTDP/CHN/ 2024-25/W-01**

**Chandina Pourashava, Cumilla**

**Resilient Urban and Territorial Development Project (RUTDP)**

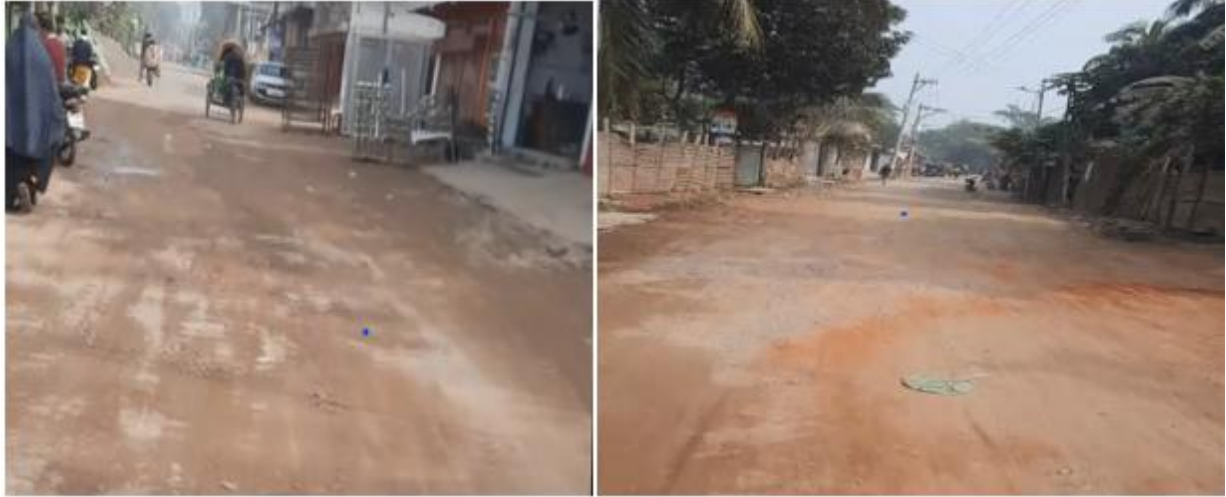
**Photographs: Existing Road Condition starting from Hazi More to Katarpul of the Subproject Site**

- Roads are **damaged, narrow, and congested**, with potholes and uneven surfaces.
- Existing drains are **narrow, silted, discontinuous, and without proper outfalls**, causing **waterlogging during monsoon**.
- **Streetlights are absent**, reducing safety at night.

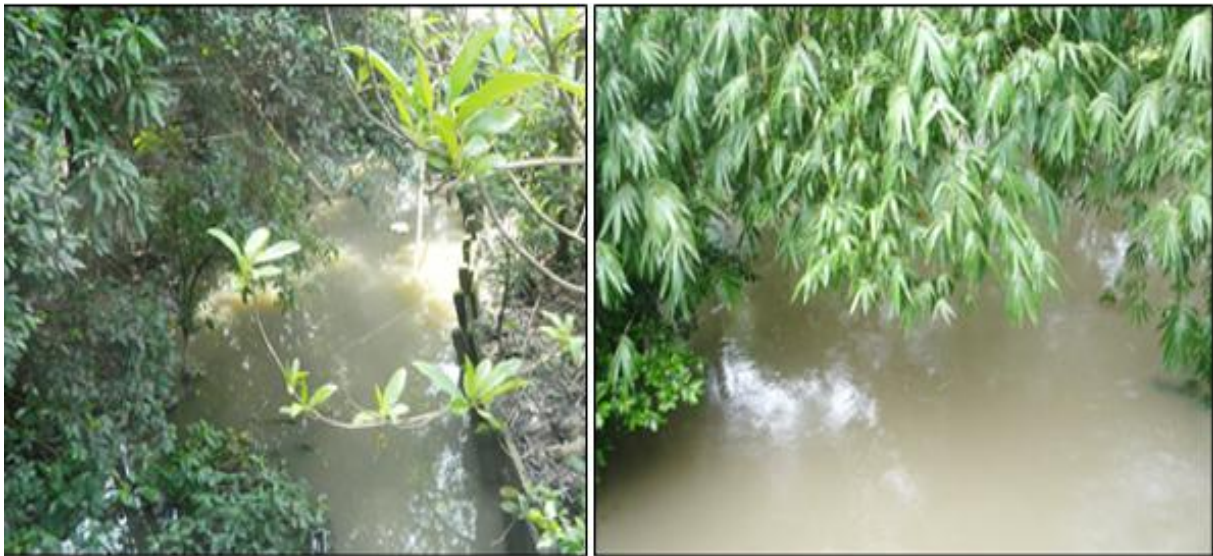
**Photographs: Current Situation of the Outfall at Subproject Site**
