ENVIRONMENTAL AND SOCIAL ASSESSMENT (ESA) REPORT FOR

Package No: RUTDP/NKH/ 2024-25/W-01 at Noakhali Pourashava, Noakhali

Resilient Urban and Territorial Development Project (RUTDP)
Sub-Project Preparation Team, RUTDP, LGED

Summary of ESA Report – Noakhali Pourashava, Noakhali Package No: RUTDP/NKH/2024-25/W-01

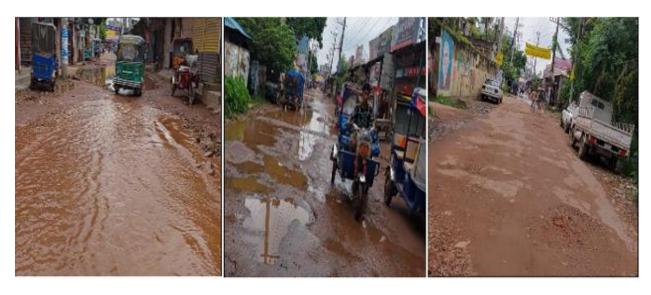
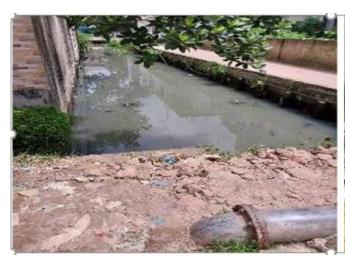
- Roads: Severely damaged with potholes, uneven surfaces, and insufficient width (3.5–7.0 m)
- Drains: Narrow, silted, damaged, and discontinuous with poor outfall connectivity to Islamia
 Khal → Noakhali Khal → Dakatia River.
- Streetlights: Largely absent, causing safety concerns at night.

- Drainage congestion during monsoon
- Damage to infrastructure and traffic disruption
- Public inconvenience and economic loss
