## **ENVIRONMENTAL AND SOCIAL ASSESSMENT (ESA) REPORT FOR**

**Package No: RUTDP/CHN/ 2024-25/W-01**

**Chapai Nawabganj Pourashava, Chapai Nawabganj**

**Resilient Urban and Territorial Development Project (RUTDP)**  
**Design, Supervision, and Management (DSM) Consultancy Services**  
**Eptisa Servicios de Ingenieria, S.L (Eptisa), Madrid, Spain**

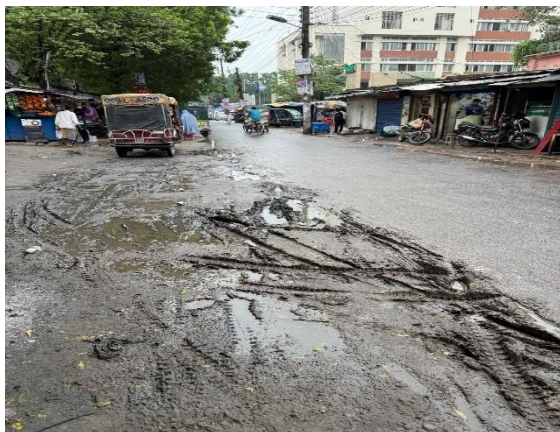
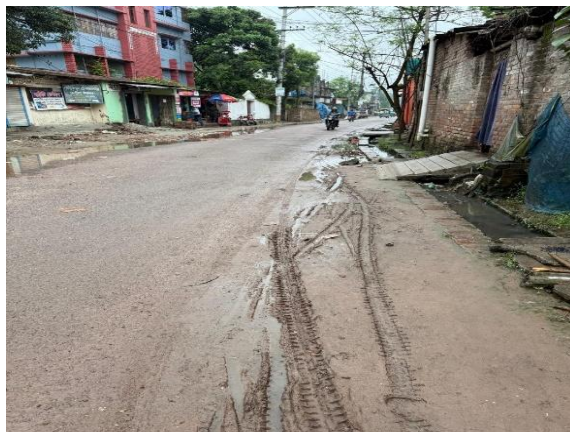
The current roads are narrow, damaged, and waterlogged with inadequate drainage. During monsoon, heavy rainfall and tidal influences cause storm-water stagnation, damaging roads and hampering livelihoods. The absence of footpaths and streetlights also poses safety risks. The proposed rehabilitation will improve mobility, reduce water logging, enhance urban aesthetics, and promote safer pedestrian movement.
